## ASTM STANDARD E 1527-00 PHASE I ENVIRONMENTAL SITE ASSESSMENT

### *Vacant Land*

*West of the Southwest Corner of Ellsworth Road and Southern Avenue*

*CES Project #03226N01D07E23 A A A*

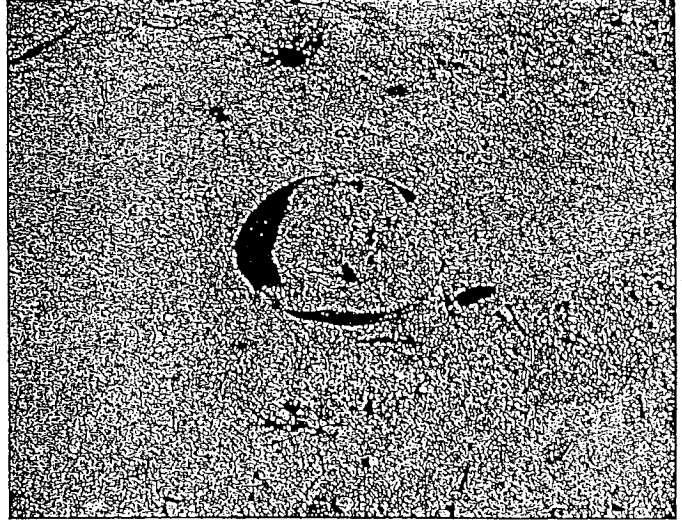
This is a view of a partially buried waste tire located on the subject site.
