## ASTM STANDARD E 1527-00 PHASE I ENVIRONMENTAL SITE ASSESSMENT

### *Vacant Land*

*West of the Southwest Corner of Ellsworth Road and Southern Avenue*

*CES Project #03226N01D07E23 A A A*

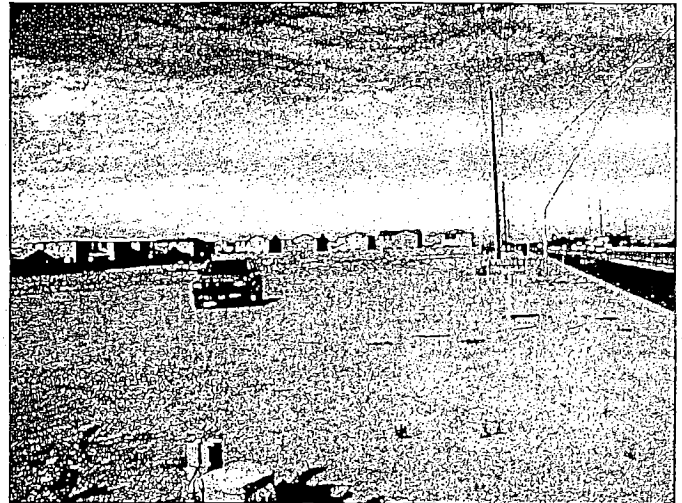
This is a view of the site from near the northeast corner of the site looking south along the eastern boundary of the site.

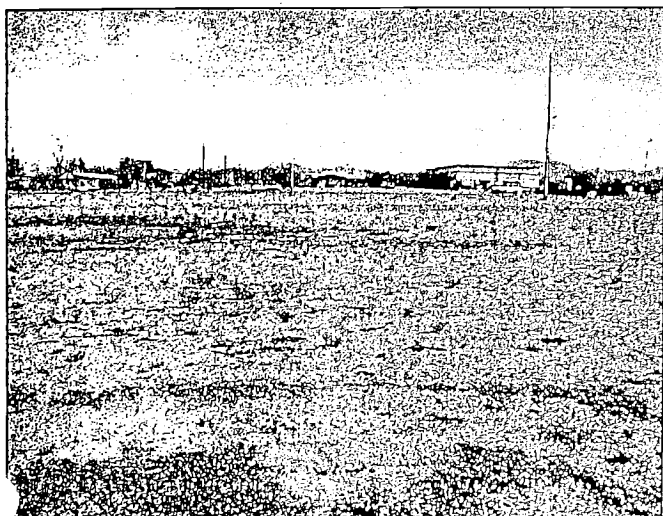
This is a view of the site from near the northeast corner of the site looking west along the northern boundary of the site.
